2023-2024 General Rate Application (GRA)

Fish Lake 2 Power Station Design

ATCO Electric Yukon
Fish Lake 2 Condition Assessment
Fish Lake, YT

Technical Report
Condition Assessment and Options Analysis

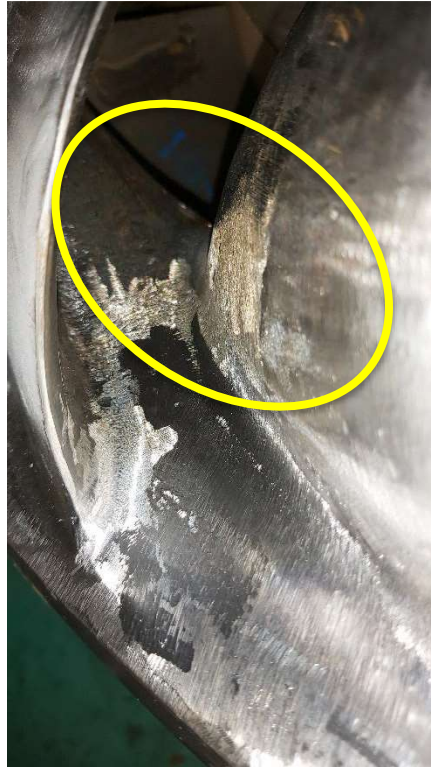
- Runner is showing frosting or cavitation on the suction sides, signifying that the flow is a little too high (as max output is below rated O/P this means head is lower than rated head – it is 6% below rated head);
- Stay vanes are very rough, high friction losses, misshaped leading edges;

Figure 2: Runner Suction Side Cavitation (expansion too severe)

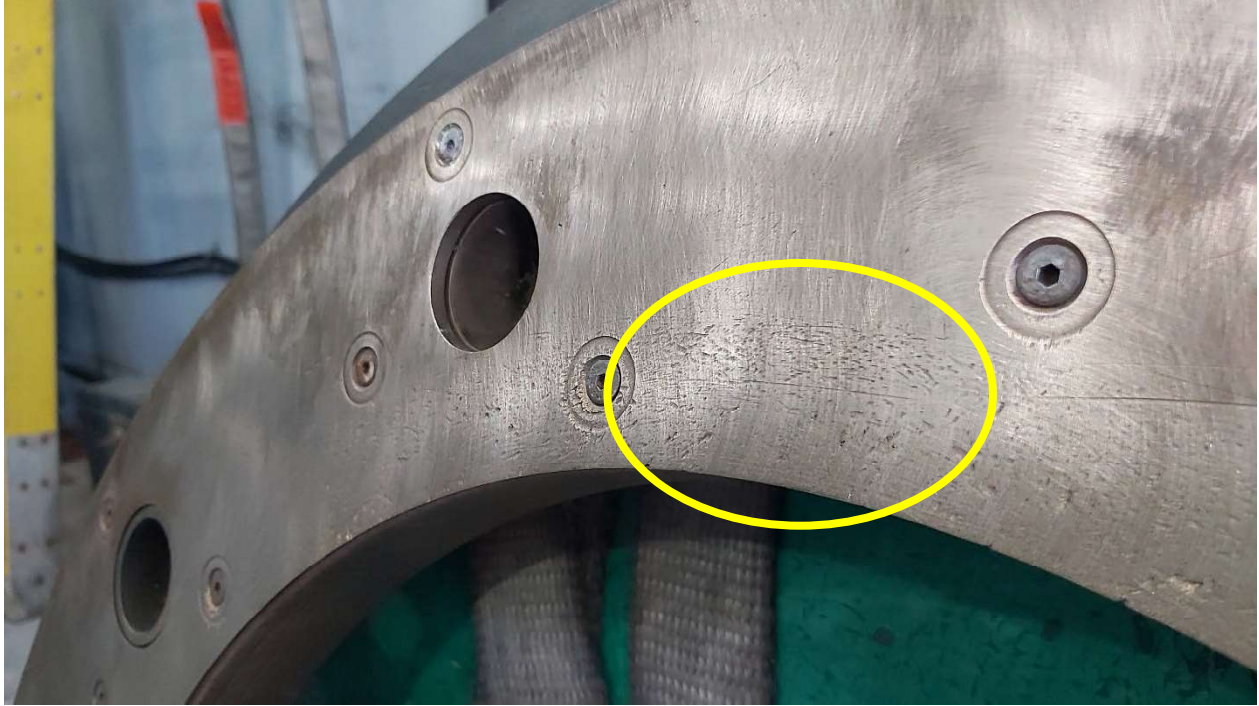
Figure 3: Lower Wear plate and Band seal Damage (Cavitation)

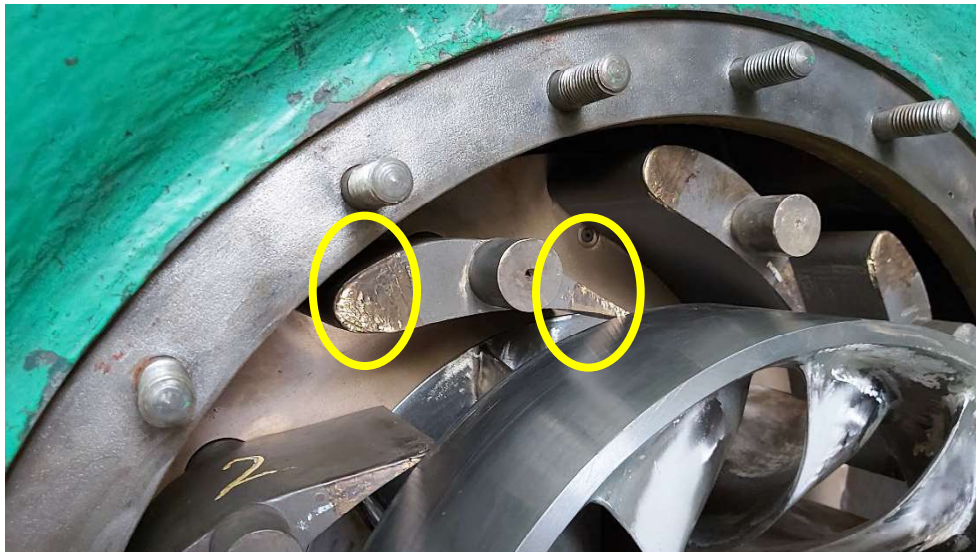
- Wicket gates show signs of leakage past lower wear rings, the upper gap could not be seen but measured 0.0015" to 0.014". The worst areas being the trailing edges. Post visit/annual maintenance TW informs us that the gap is now reduced to 0.4mm;

Figure 4: Wicket Gate Damage

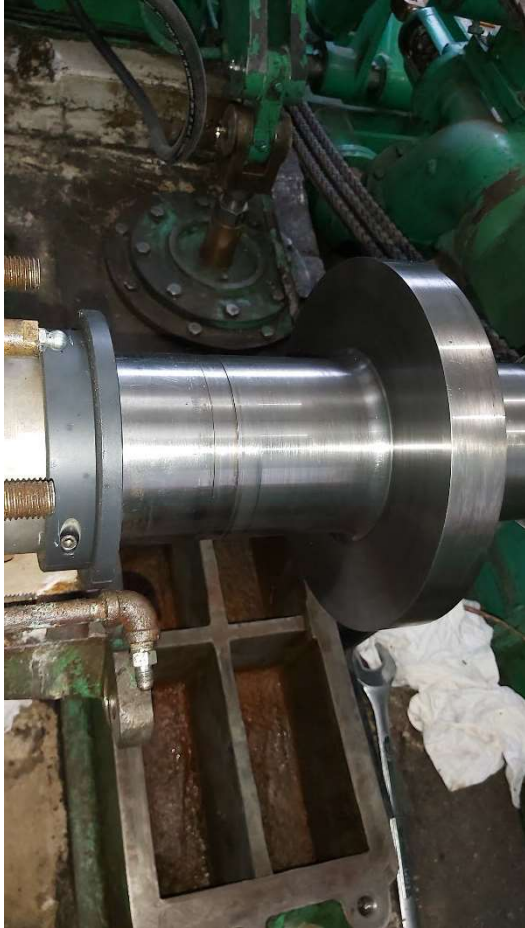
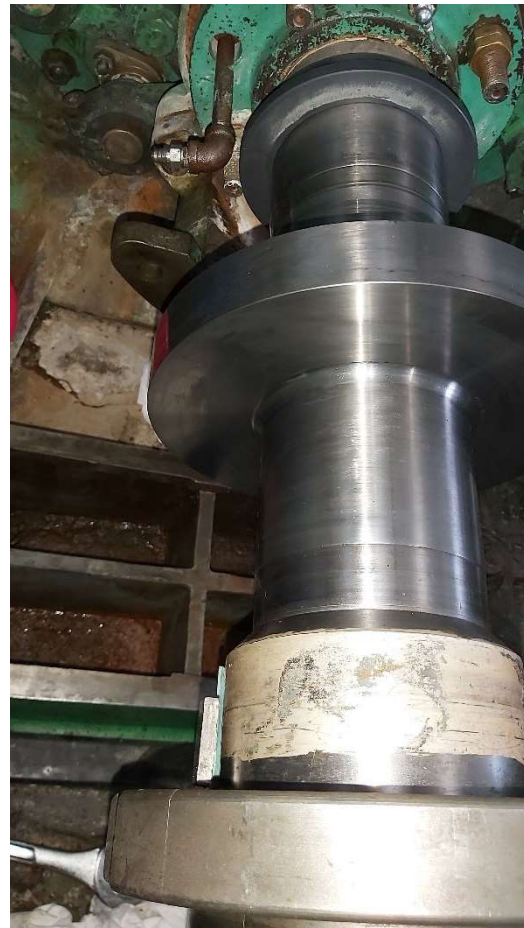
Figure 5: Turbine Journal Bearing Shaft Scoring

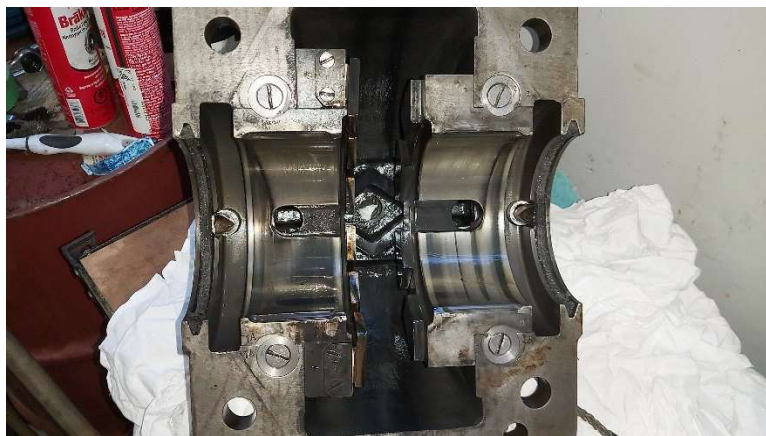
Figure 6: Turbine Journal Bearing Minor Wear

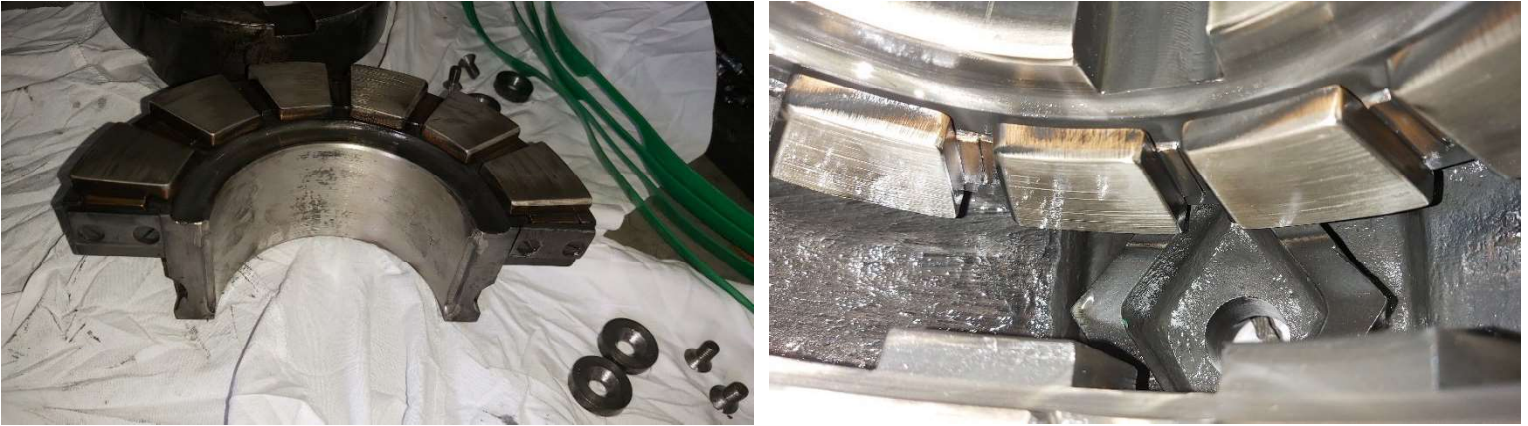
Figure 7: Thrust Pad Damage

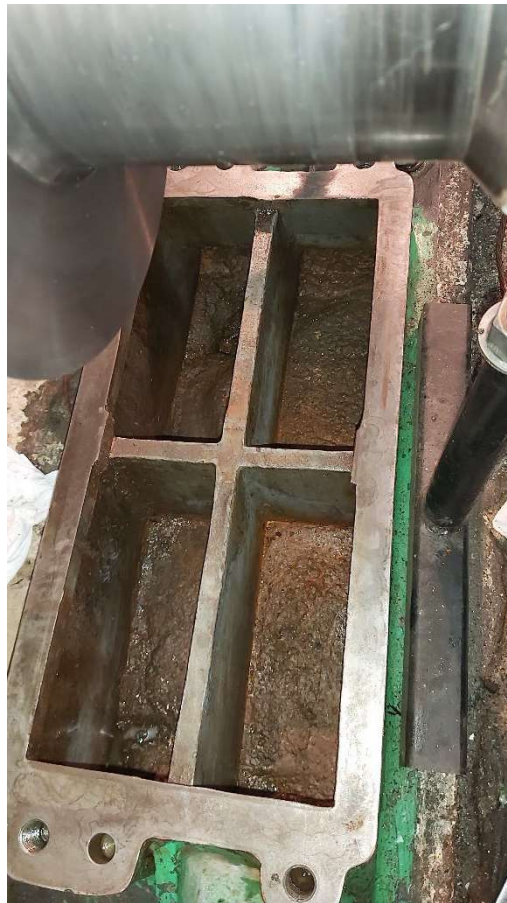
Figure 8: Turbine Bearing Pedestal Hole to Ground

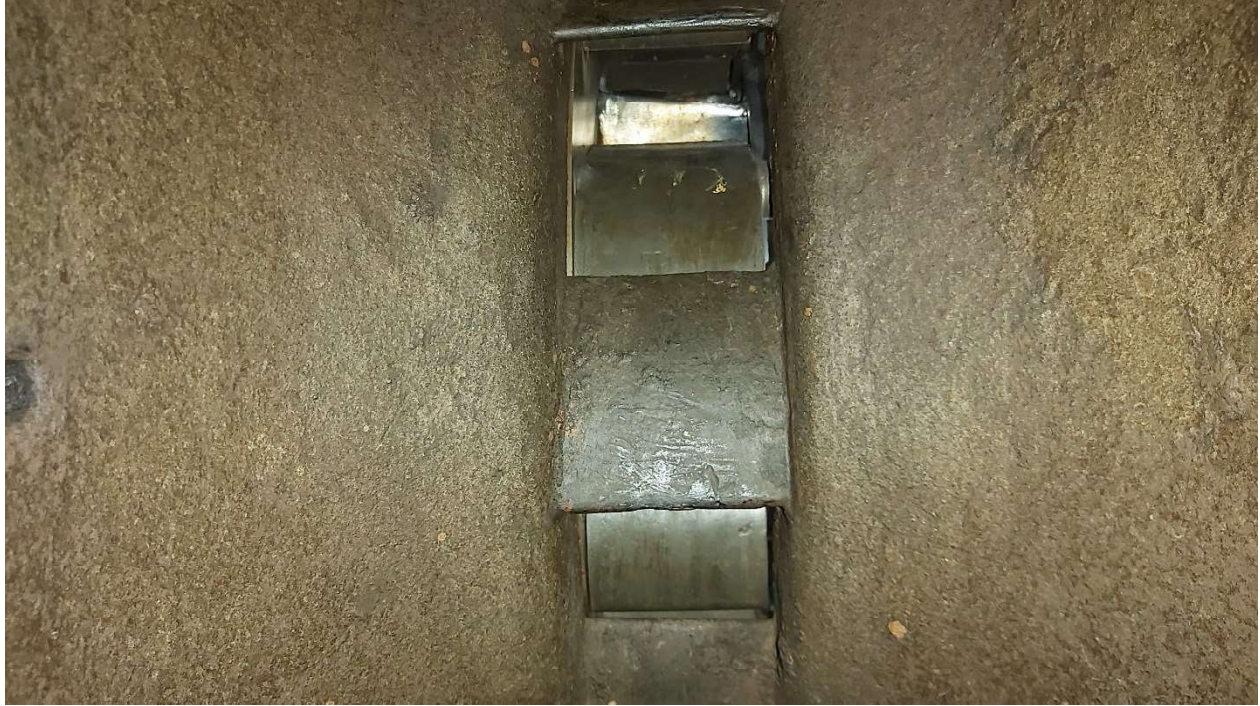
Figure 9: Scroll Case and Stay Vane High Friction Condition

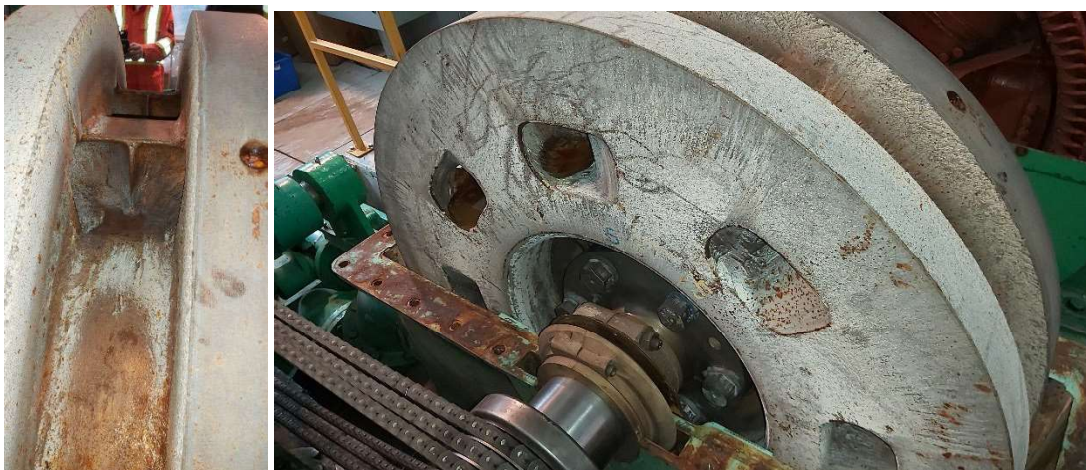
Figure 10: Brake/Flywheel Damage

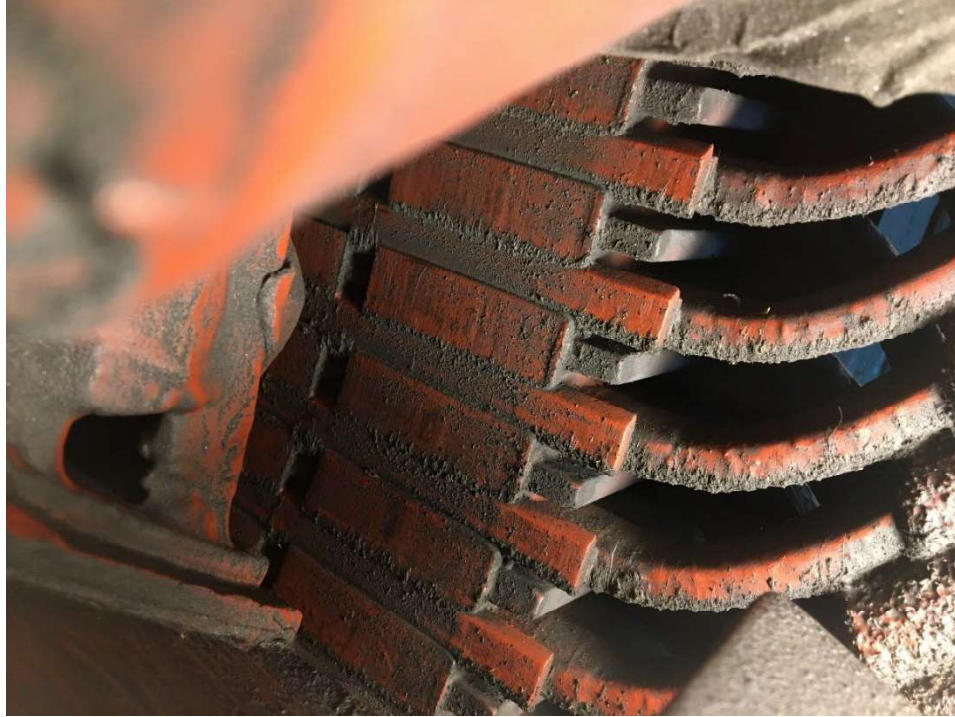
Figure 12: Stator and End Turns with Carbon Dust Buildup

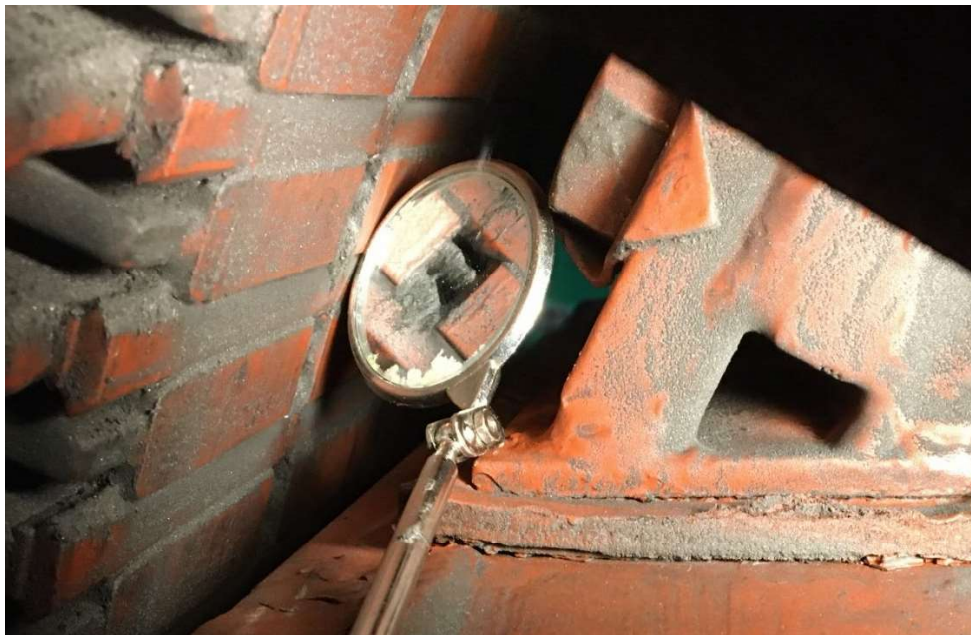
Figure 13: Inspection Partially Obstructed Stator Slot

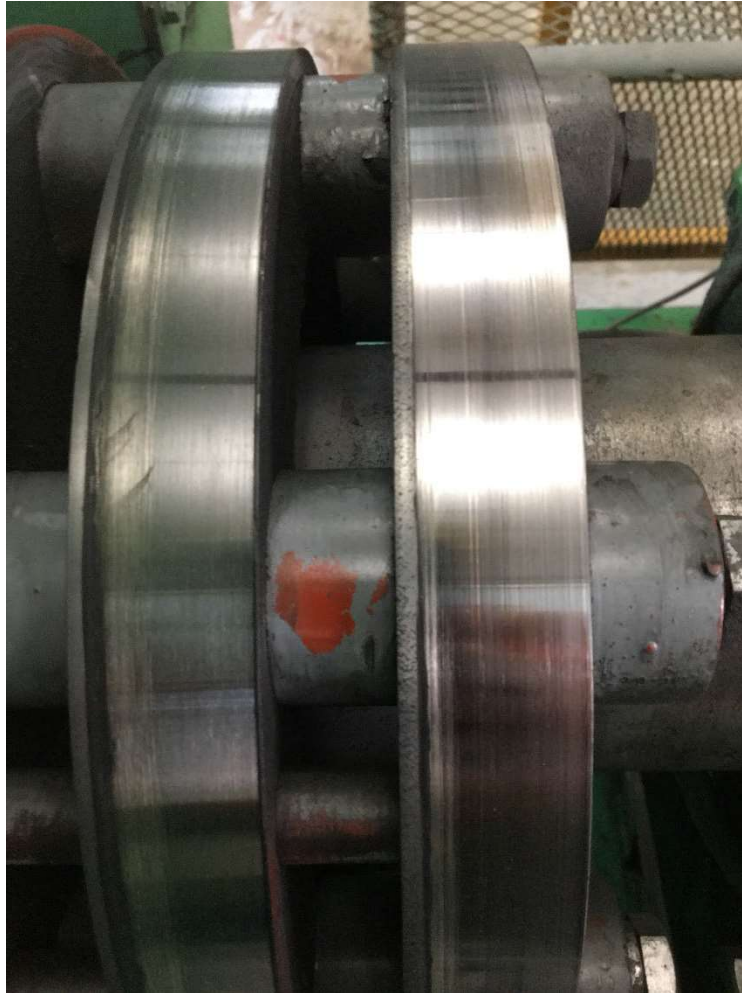
Figure 15: Main Slip Rings

The main slip rings are smooth but have some streaking. The brush holder is solidly mounted and holds four brushes per ring. The frequency of brush change out needs to be confirmed by ATCO. BBA recommends cleaning to remove the streaking.

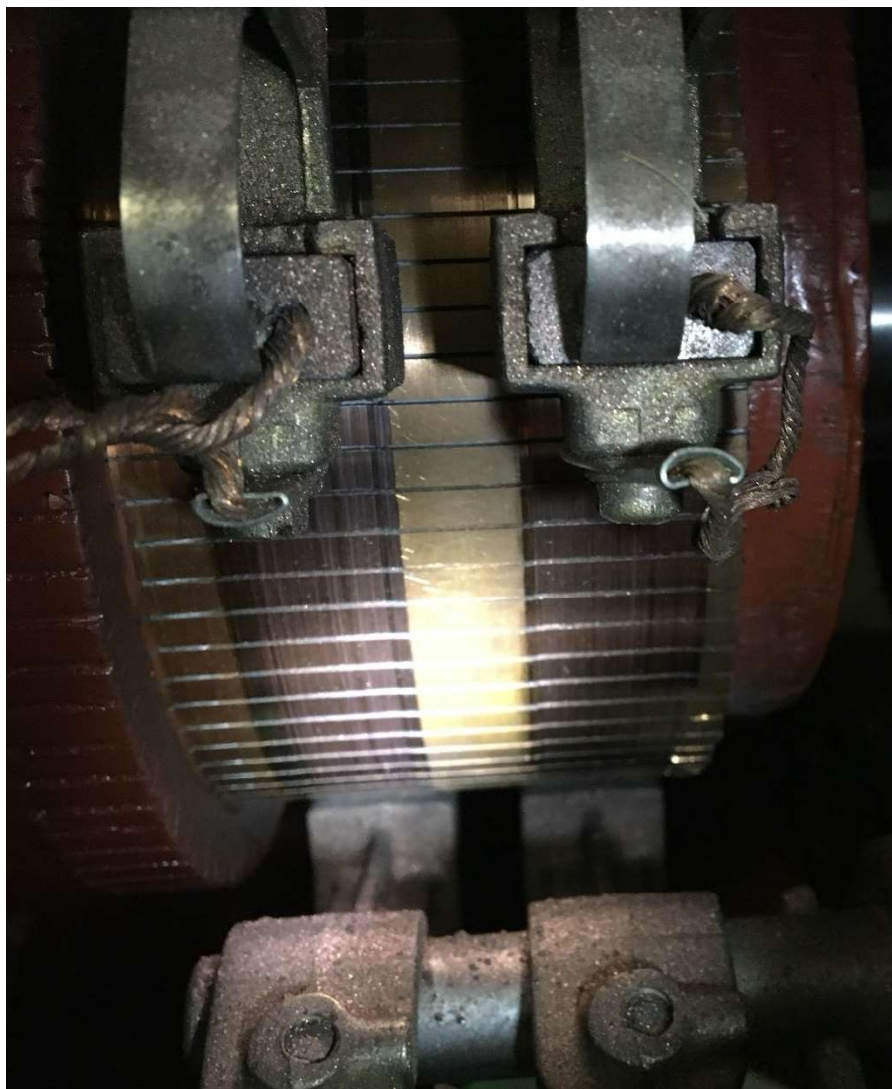
Figure 16: DC Generator Commutator

The Maven Report suggests that different brush densities and adjustment of the brush holders be further investigated. In addition, each time the commutator needs resurfacing the work needs to be synchronised with a suitable unit outage window.

To eliminate brush and commutator maintenance and extend life, the removal of the DC generator and replacement with a new static exciter should be considered. This would tie in nicely with a P&C upgrade.

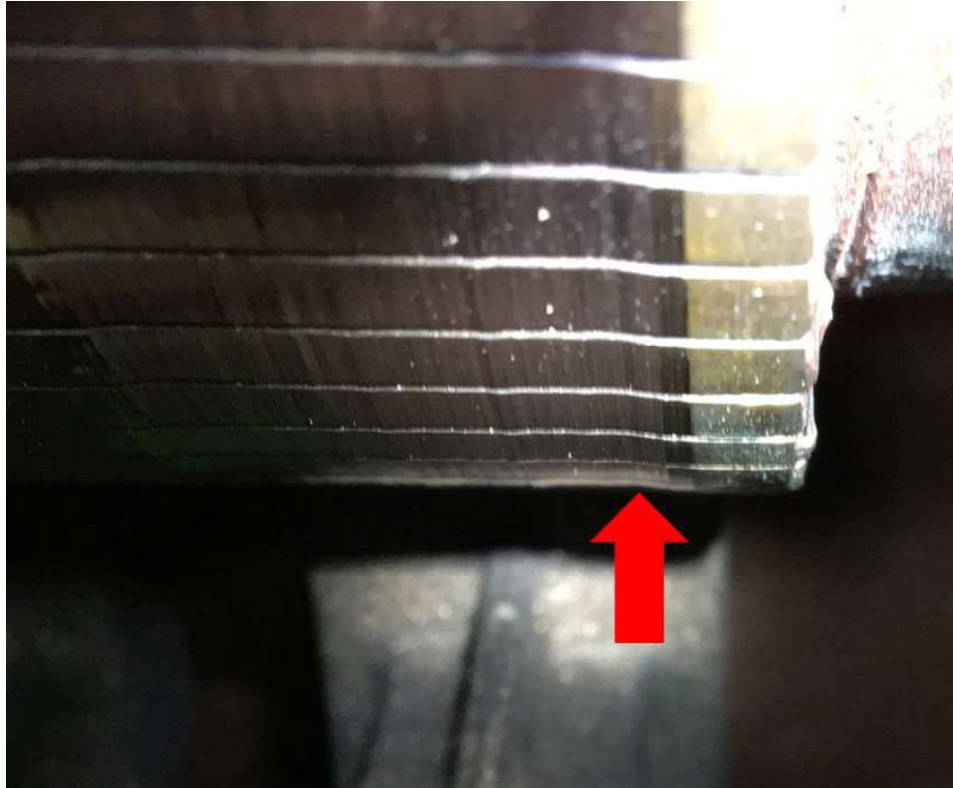
Figure 17: Groove Worn in Commutator

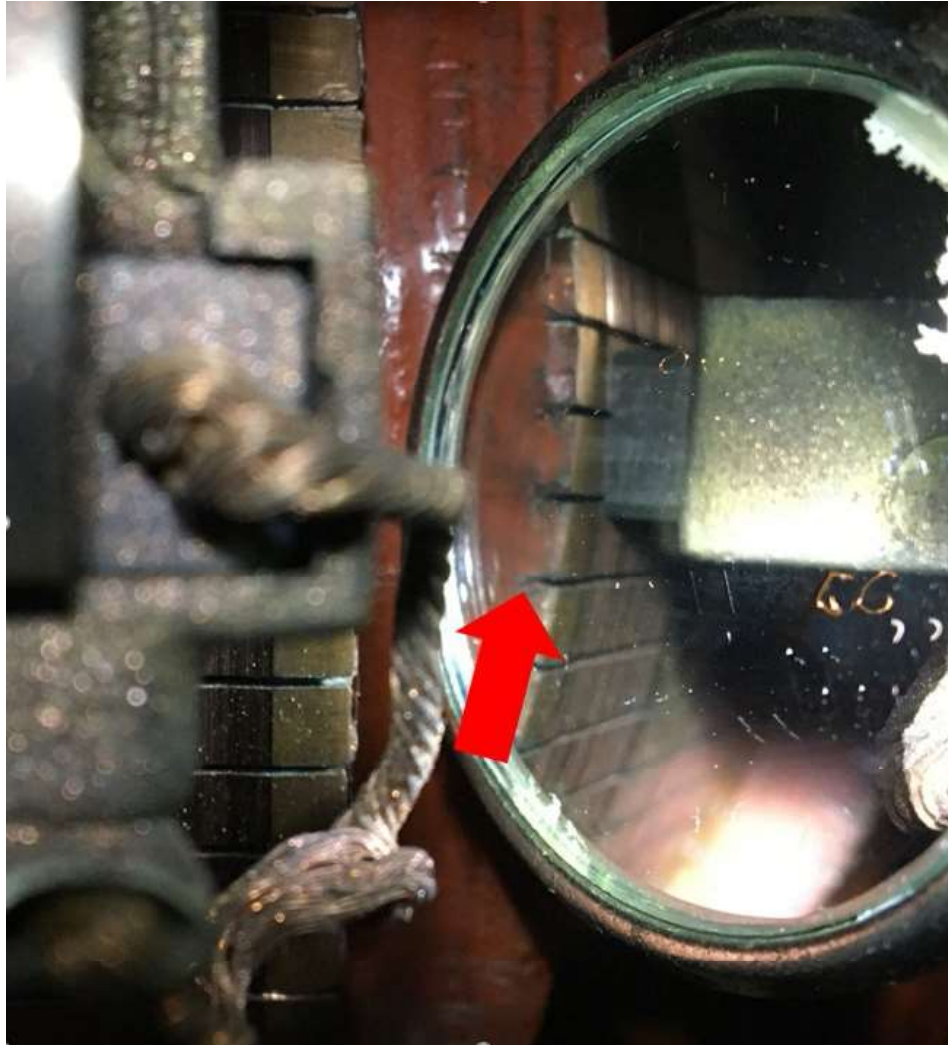
Figure 18: Commutator Remaining Surface (~3 to 4mm)

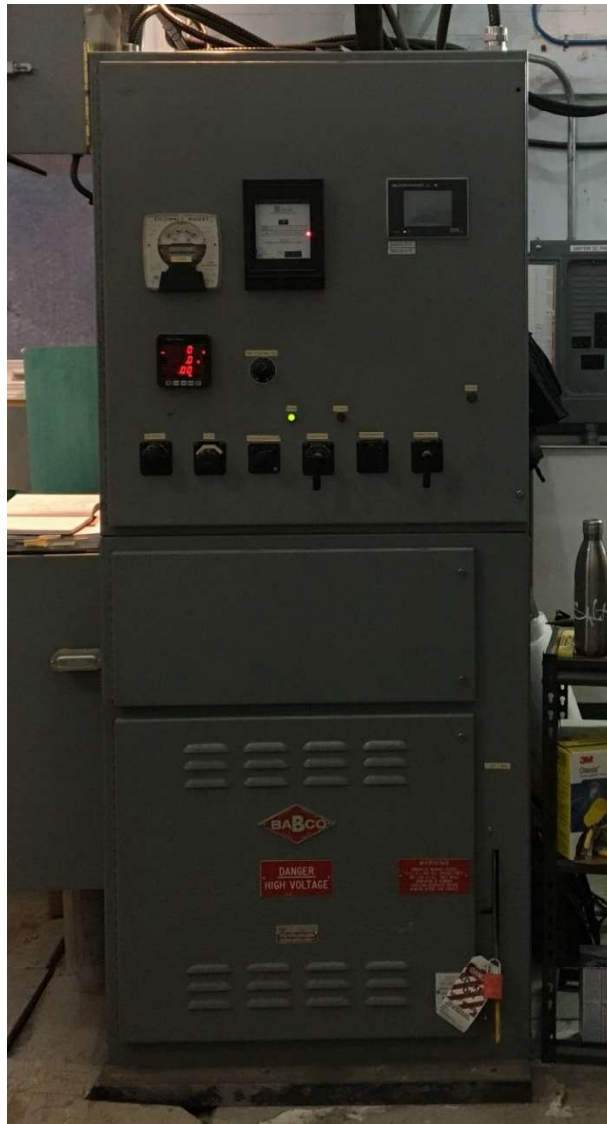
Figure 19: P&C and SWGR Panel

The switchgear and P&C are in a combined cabinet with a 4kV vacuum circuit breaker in the bottom compartment, CTs and PTs in behind and the P&C components isolated from the MV gear in their own cabinet above. It is worth noting that this equipment appears to have been installed in approximately 1999 and is now 23+ years old.

The position and location of the generator controls adjacent to the running equipment and directly above the generator circuit breaker poses somewhat of a safety risk to the operator.

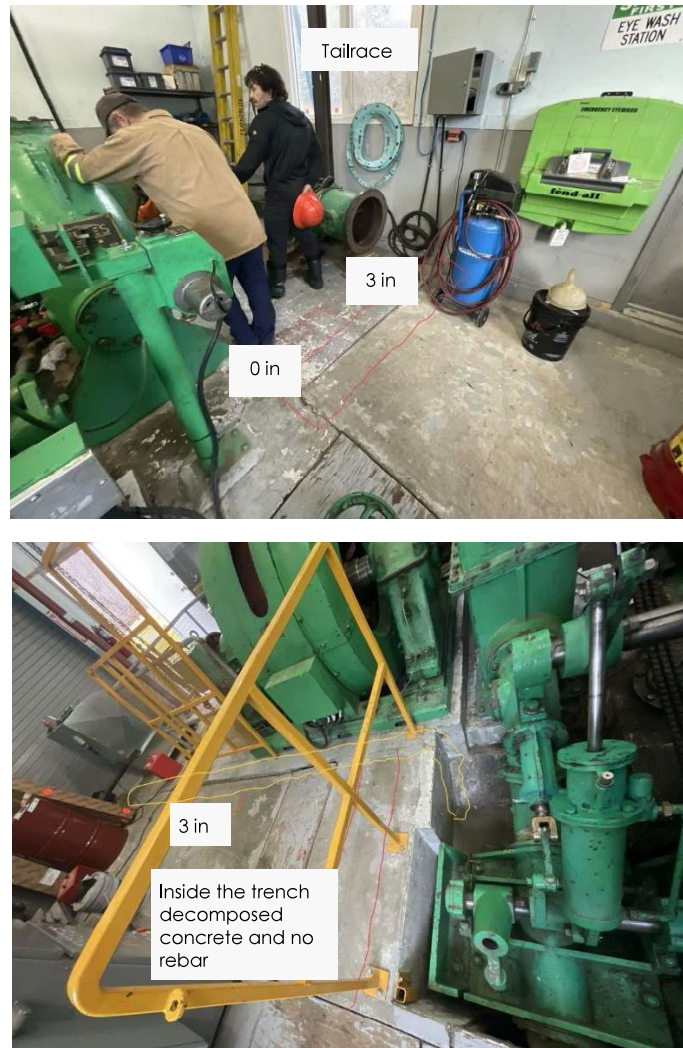
Figure 22: Differential settlement between the concrete block and slab on grade

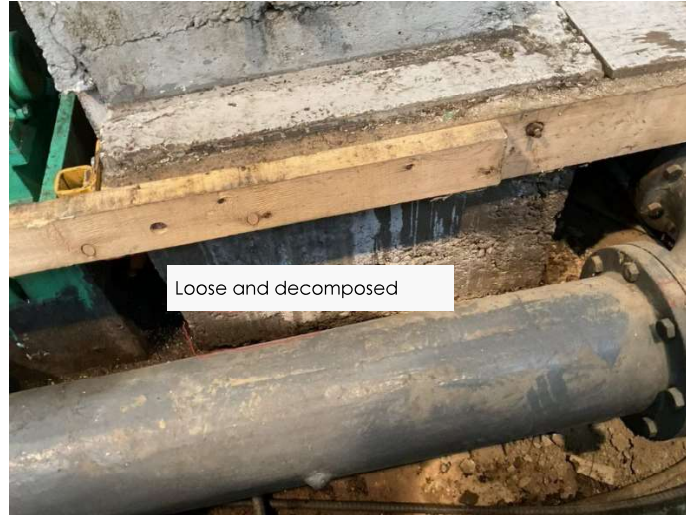
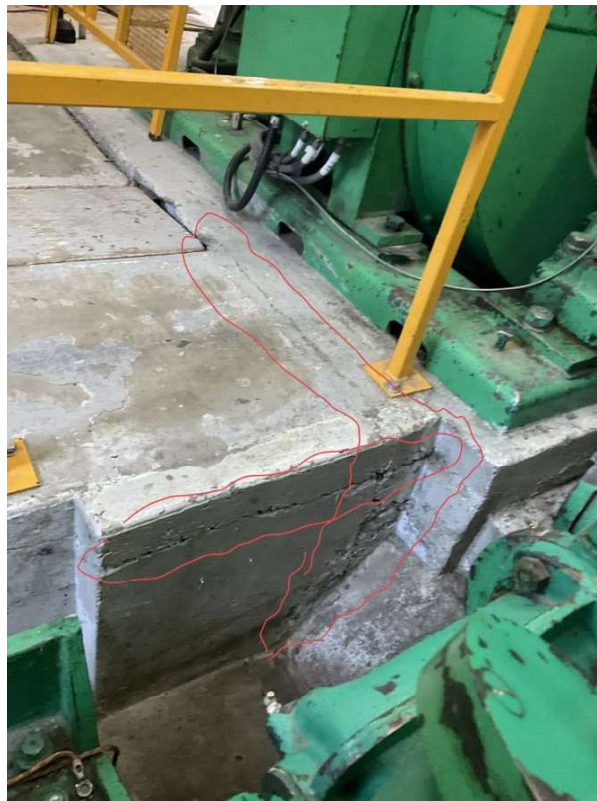
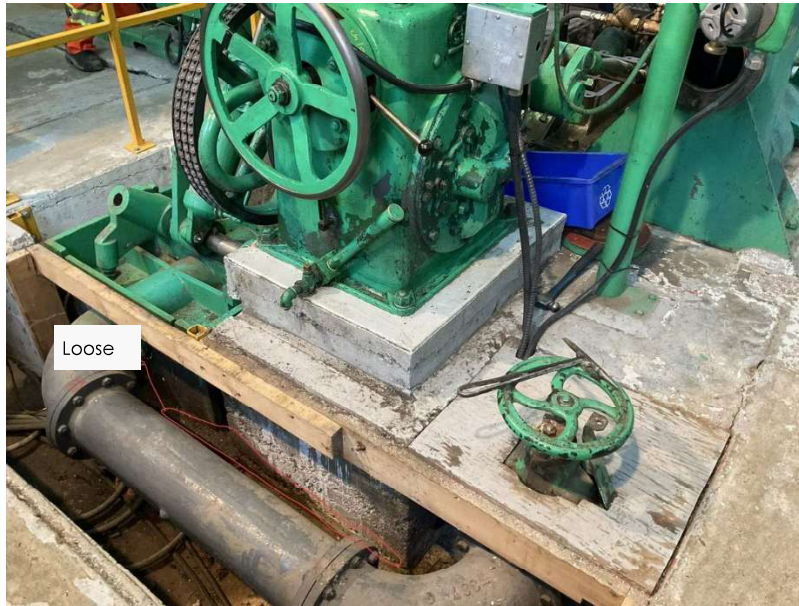
Figure 23: Loose and degraded concrete under the block concrete and inside the trench

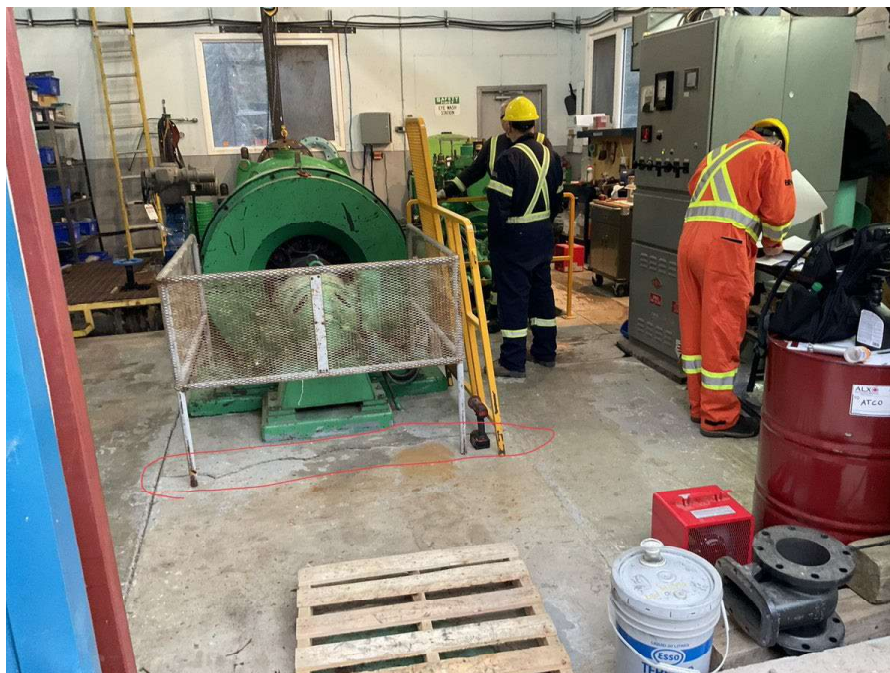
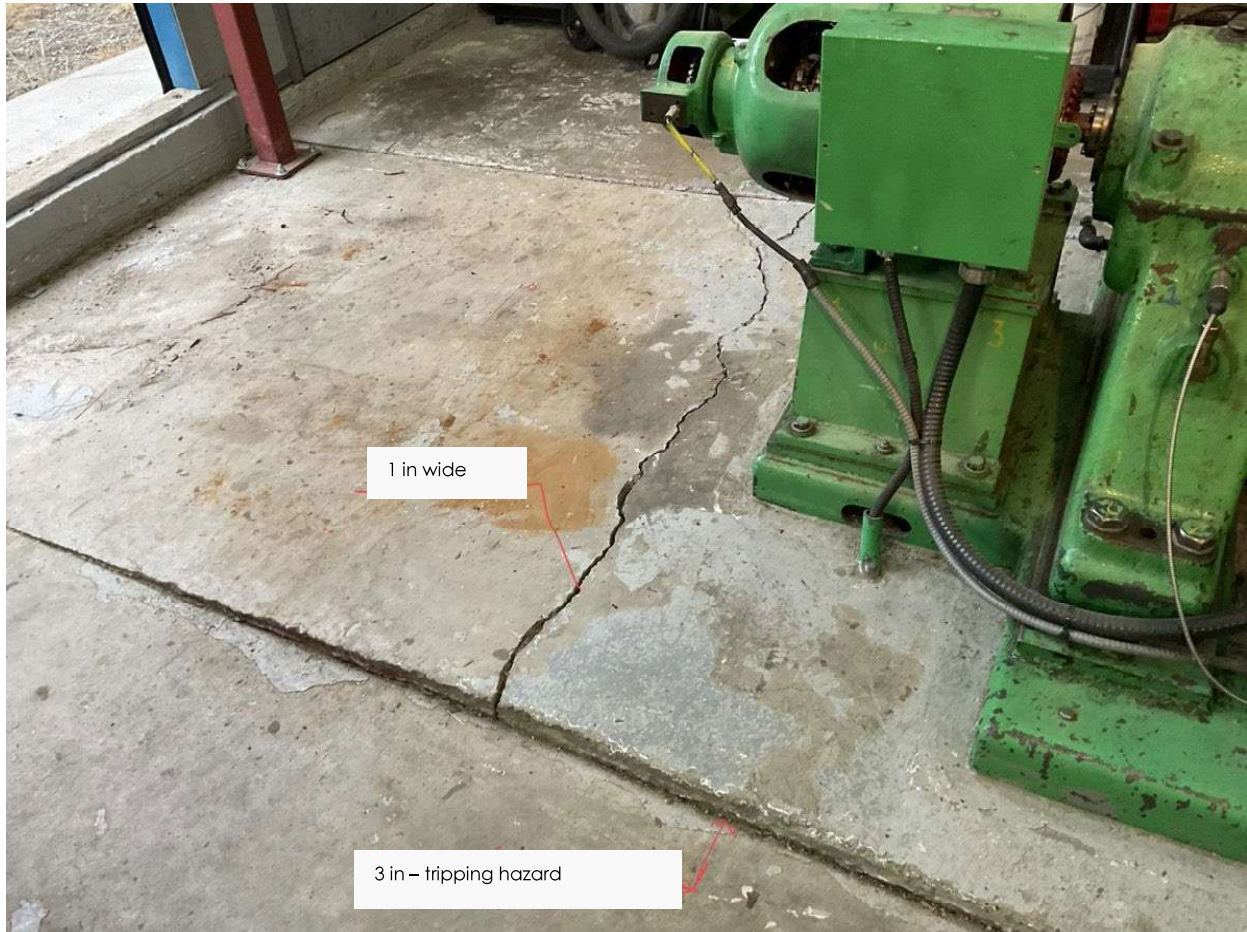
Figure 24: 1 in wide crack on the floor and settlement between the block concrete and building slab

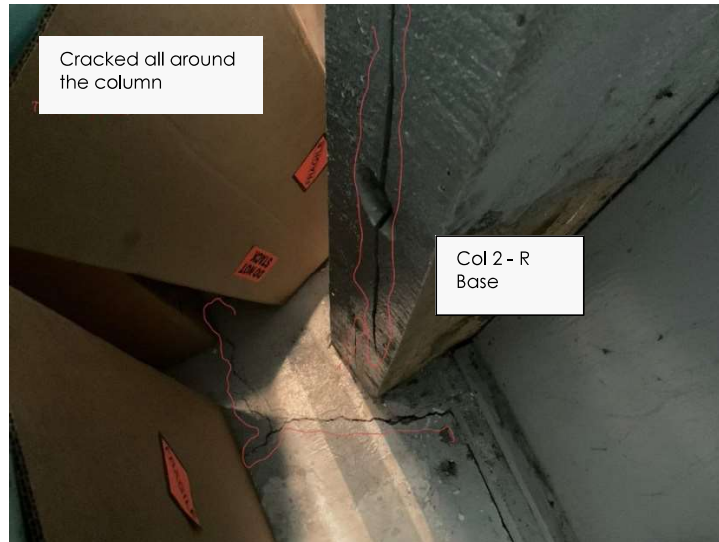
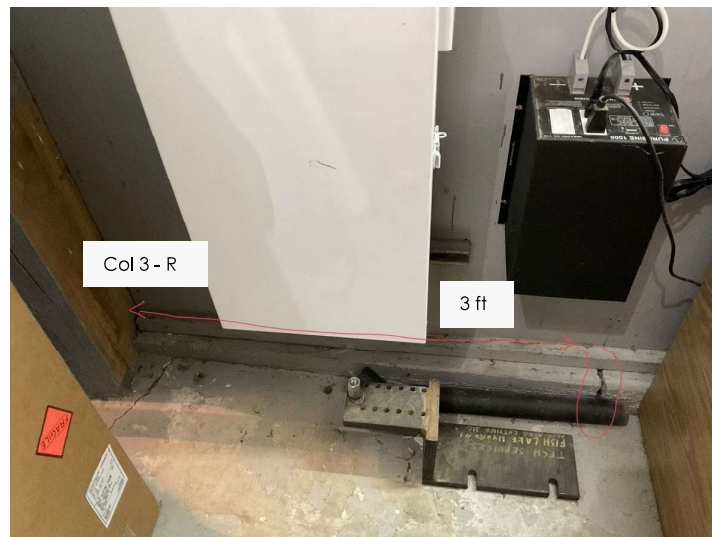
Figure 25: several cracks on the pony walls and column bases

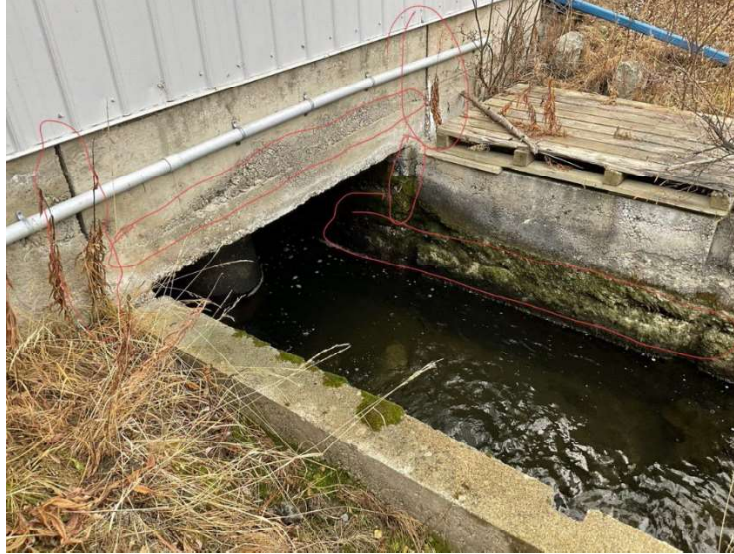
Figure 26: degraded concrete on tailrace walls

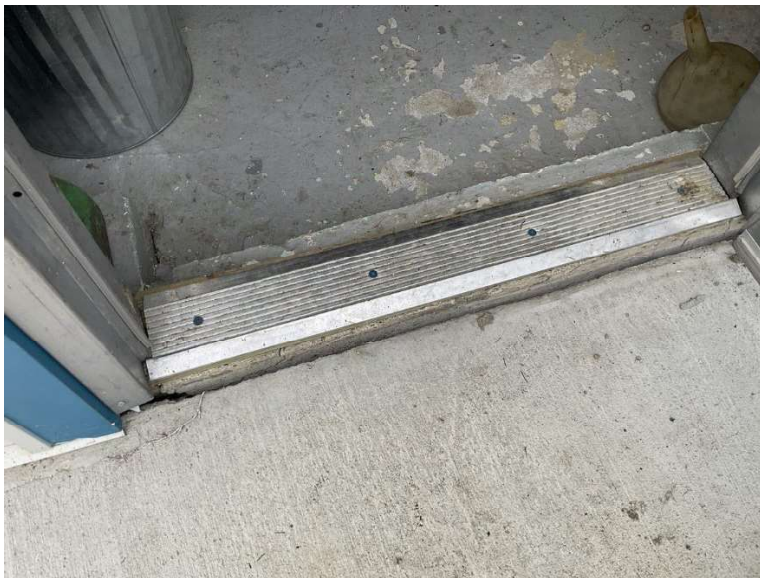
Figure 27: Differential settlement outside and inside the building

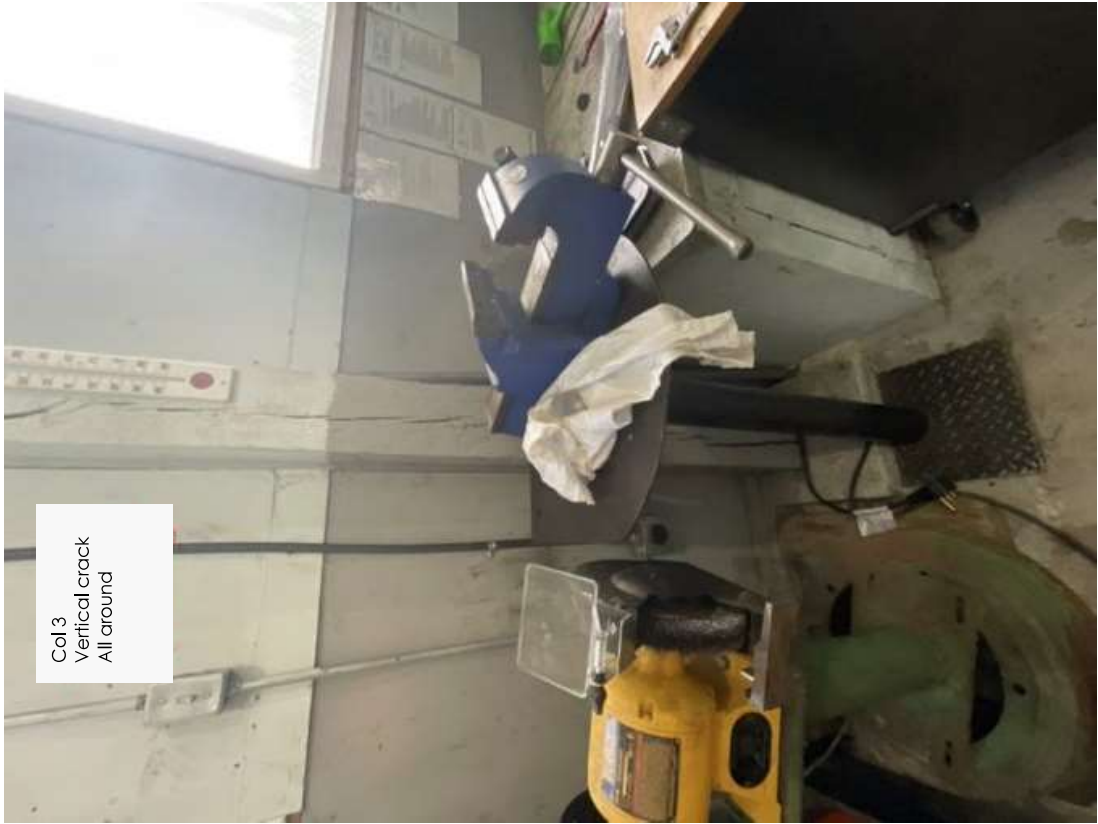
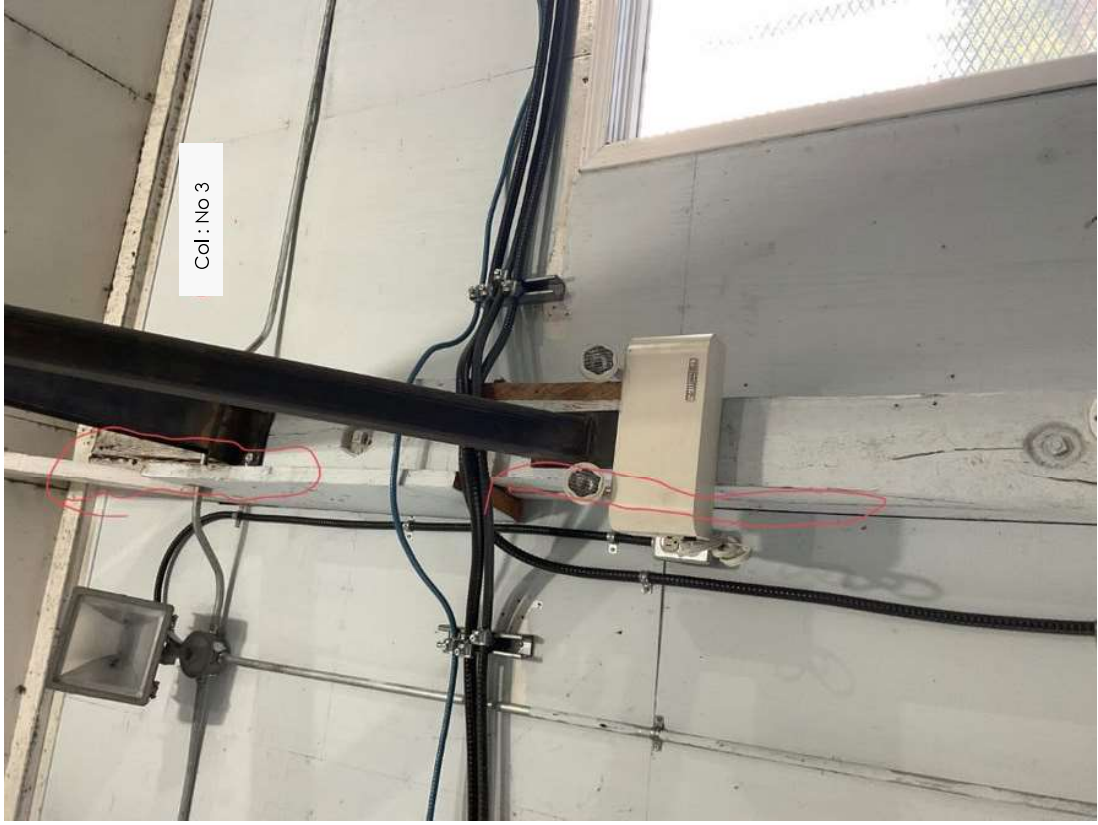
Col : No 3

The following photographs show several vertical continuous cracks and column separation gaps.

Col3
Vertical crack
All around
