2023-2024 General Rate Application (GRA)

Fish Lake 2 Power Station Design

ATCO Electric Yukon
Fish Lake 2 Condition Assessment
Fish Lake, YT

Technical Report
Condition Assessment and Options Analysis

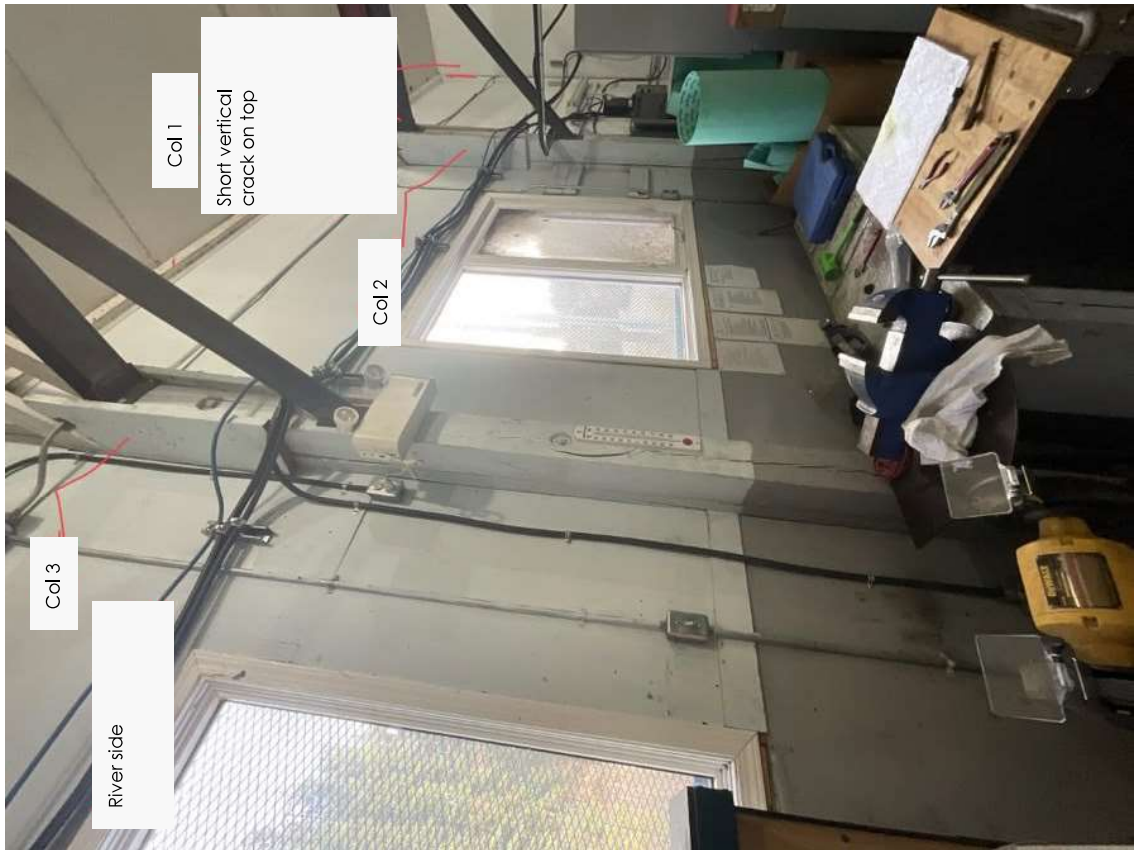
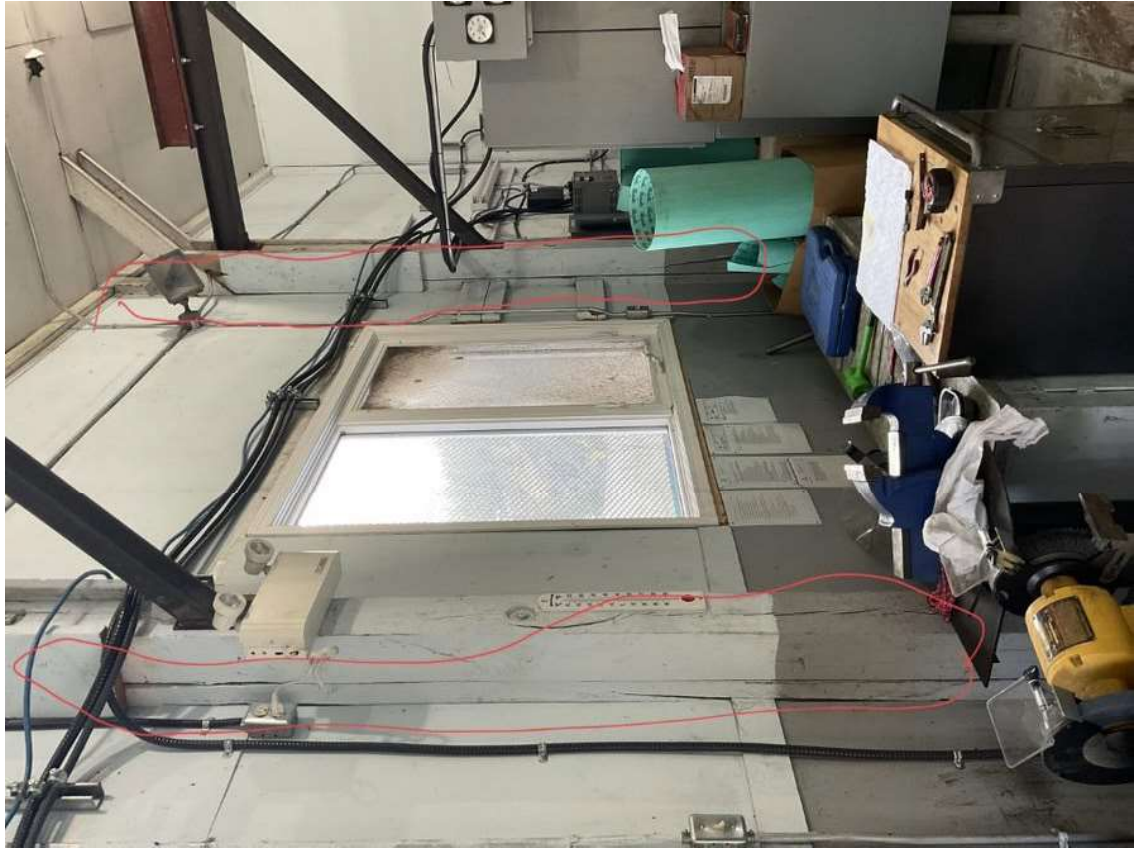
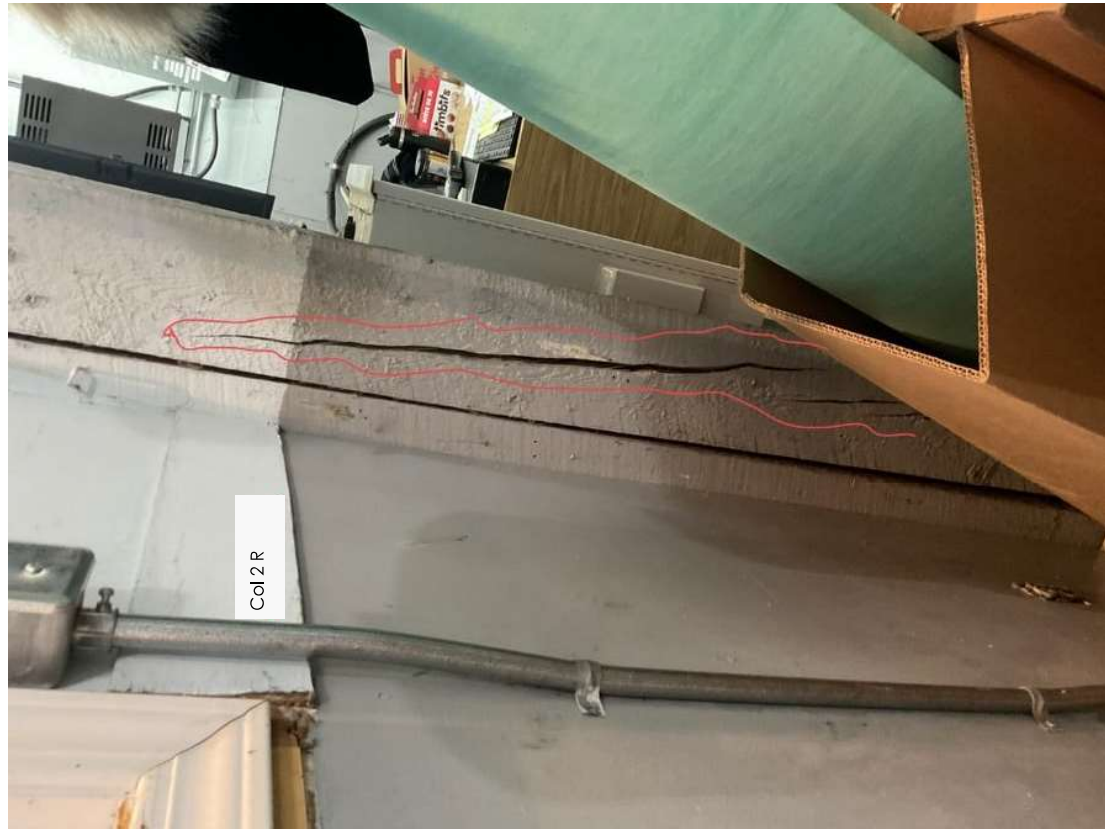
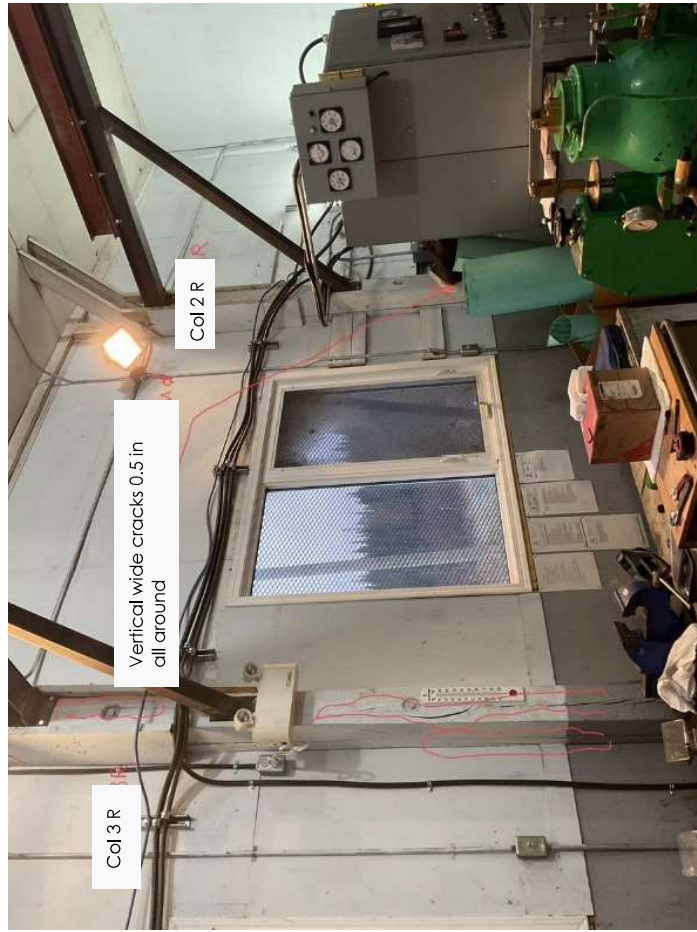
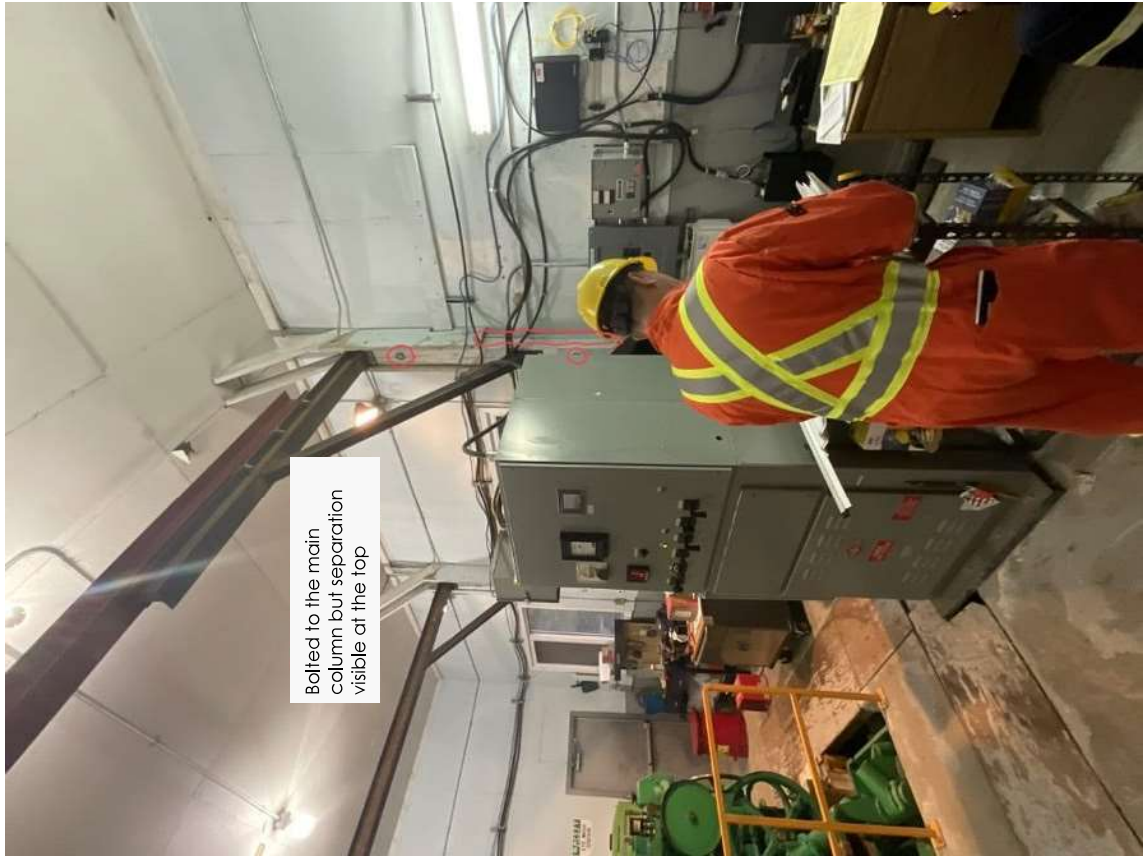
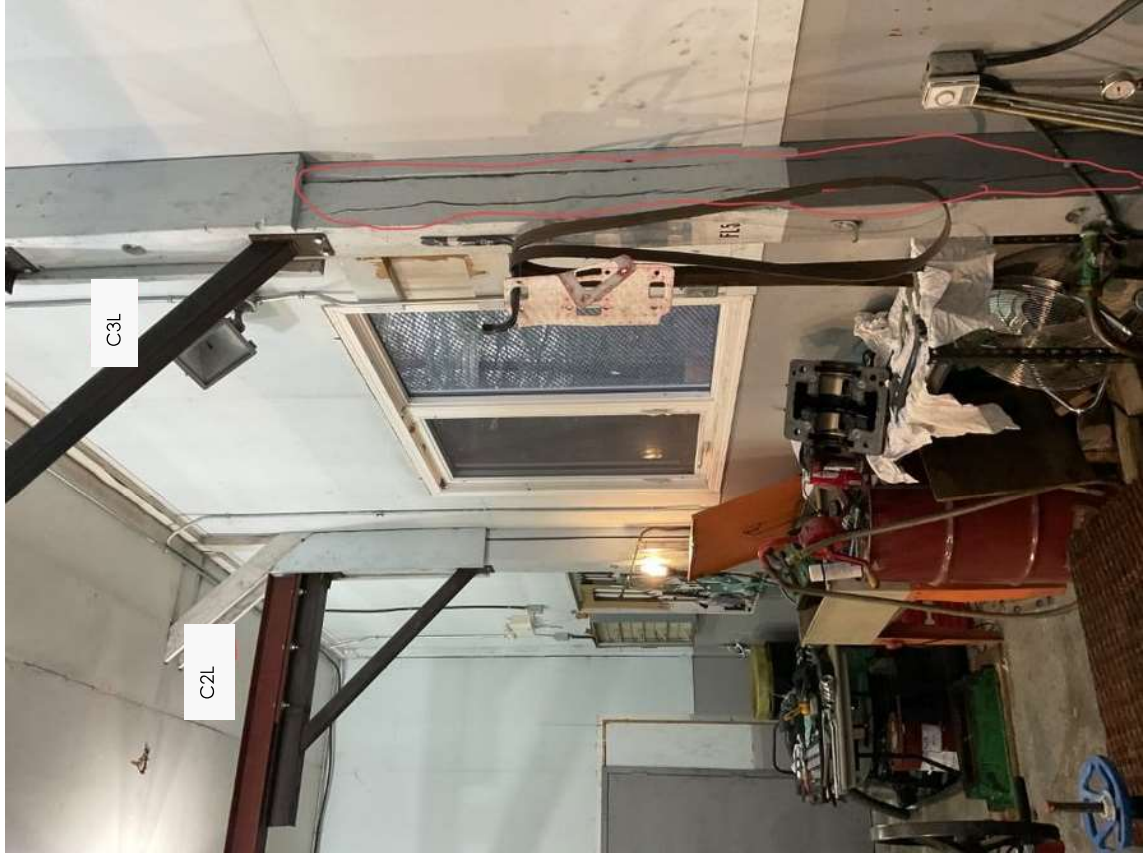
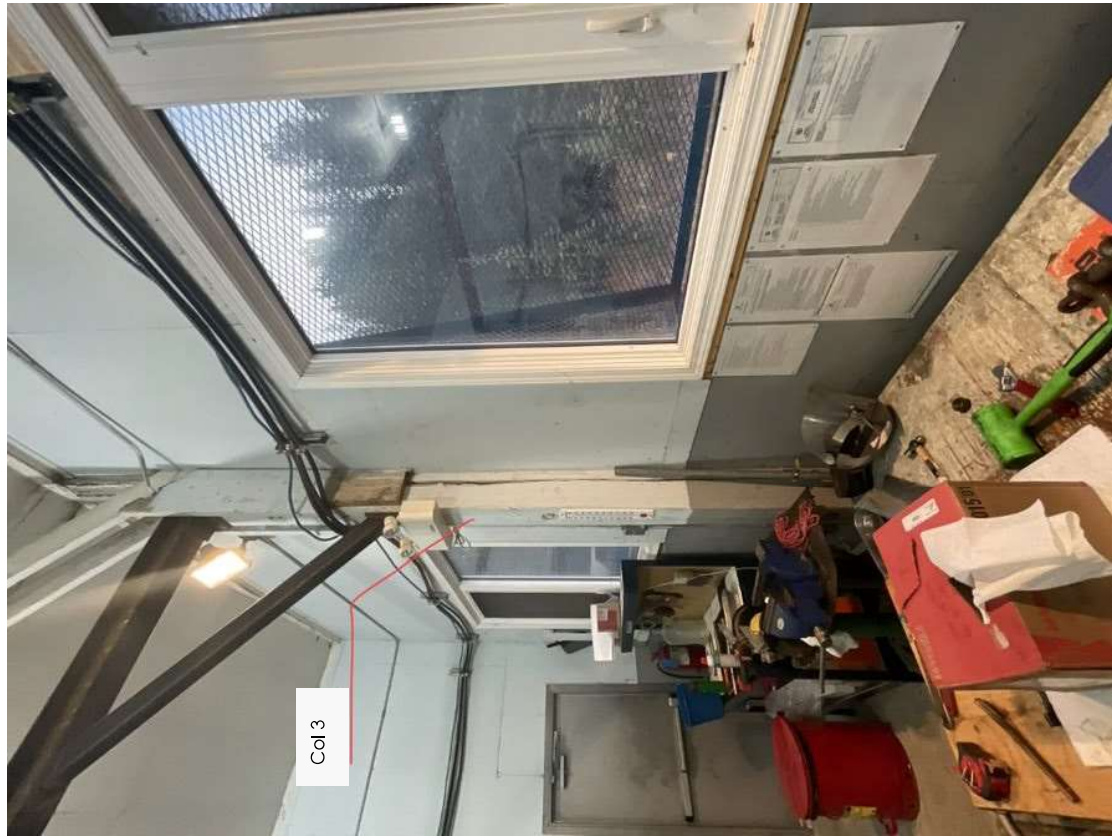
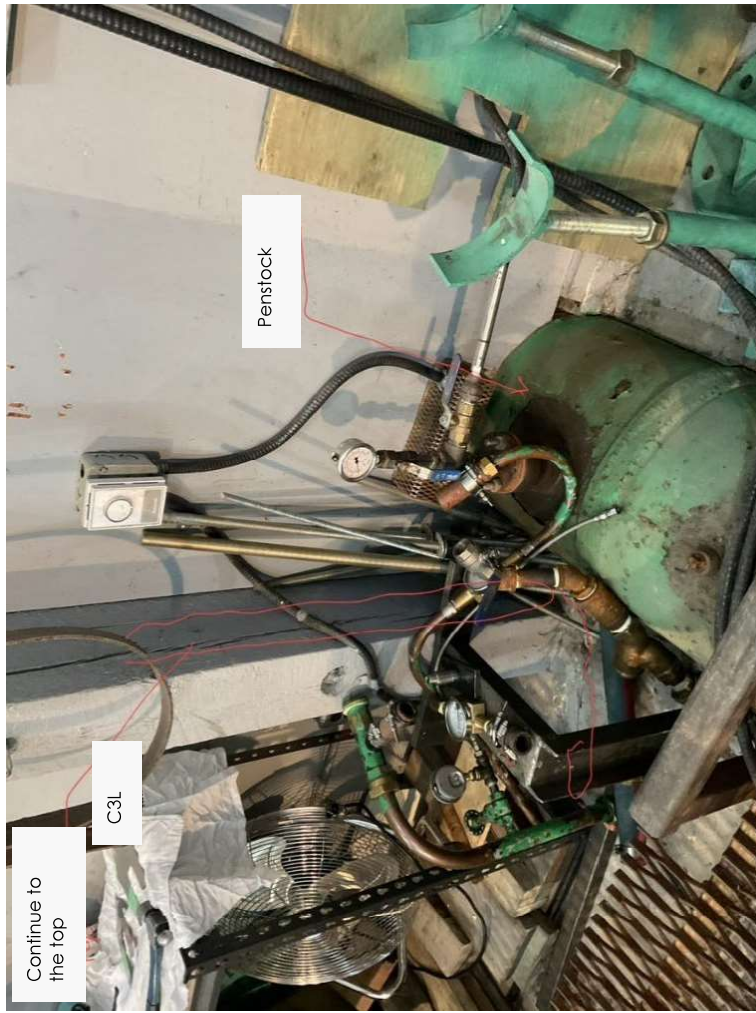
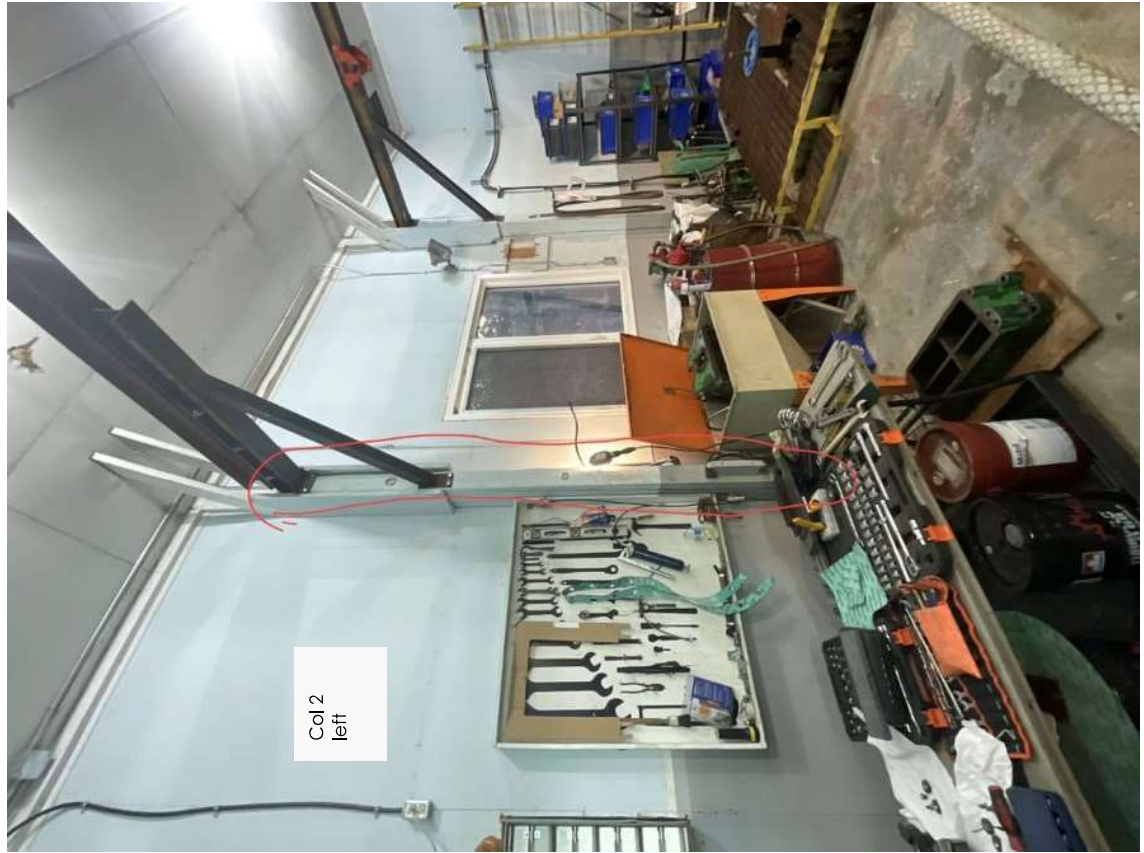
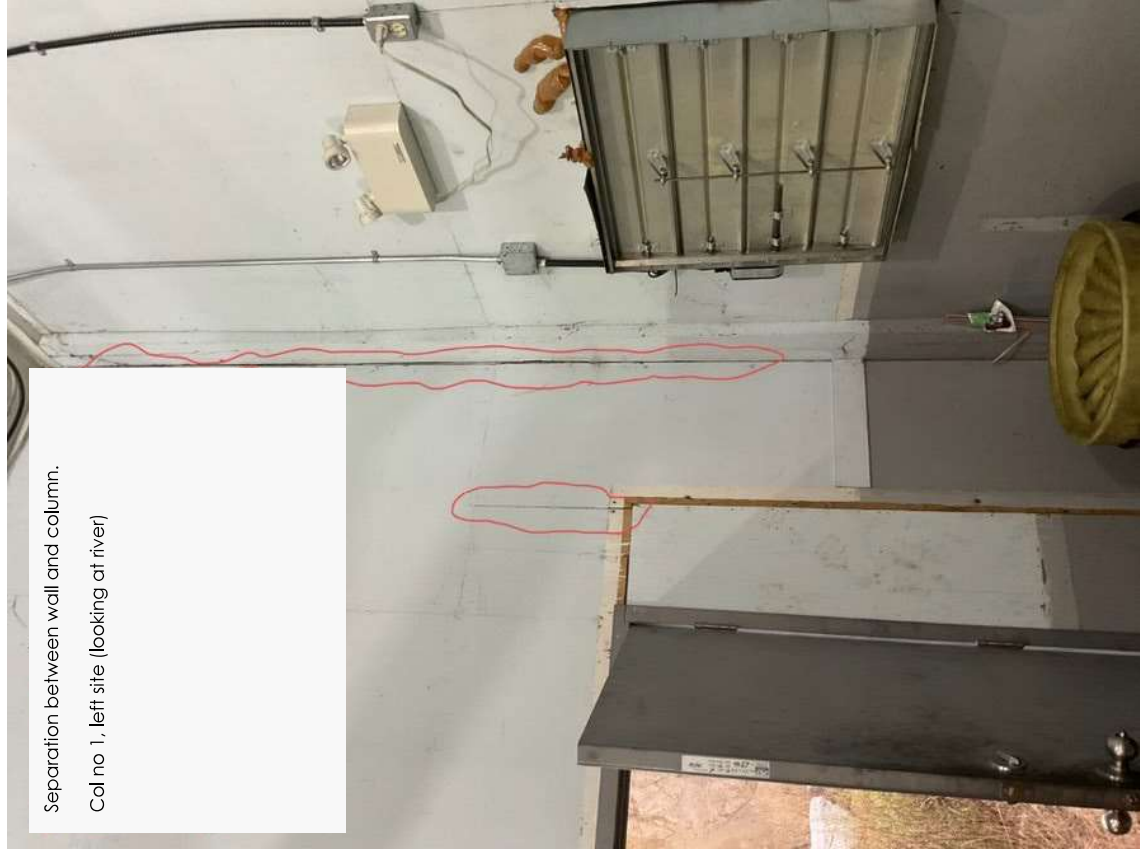
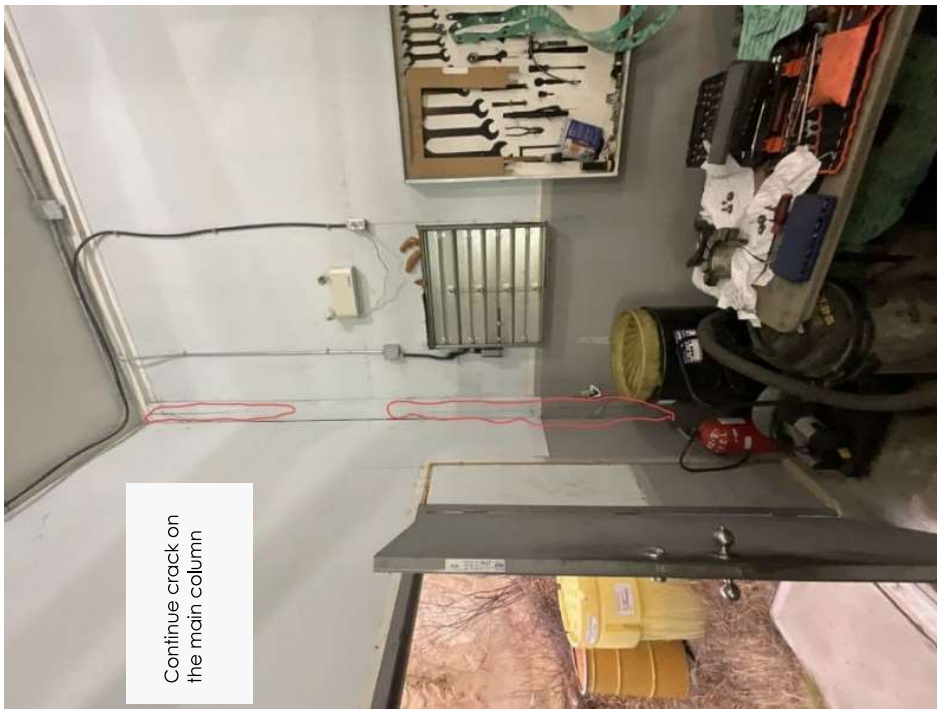
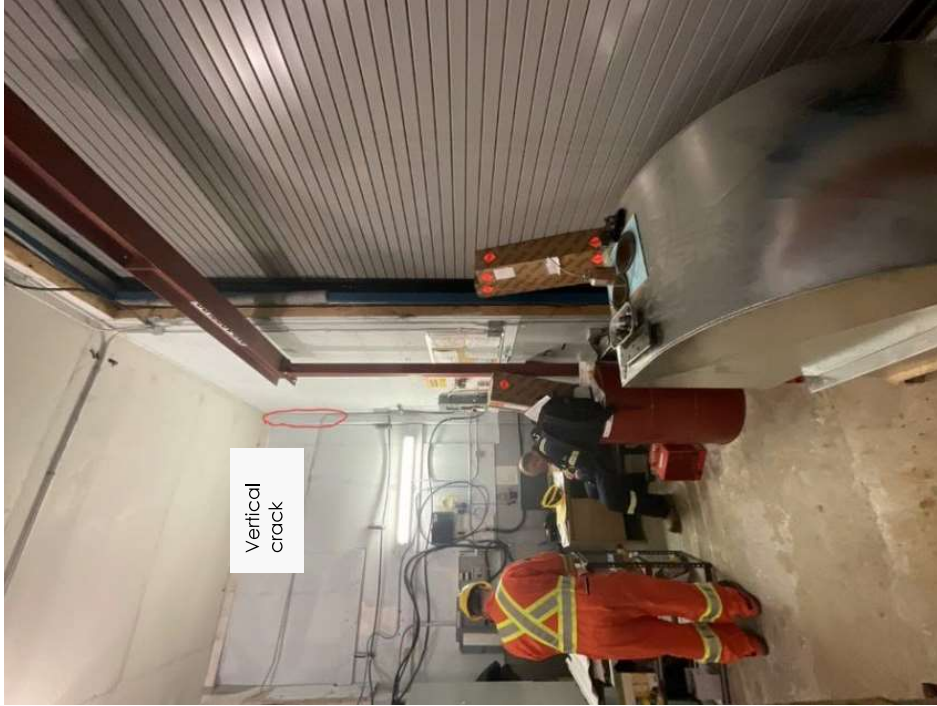
Several cracks were observed on the floor on and around the monorail columns (see Figure 28).

The general visual inspection of the visible structural elements shows that the wooden structure is not in fair condition. The wooden structure is not expected to have any lateral capacity during any seismic event. These structural elements must be retrofitted or replaced.

Figure 28: Cracks on main columns

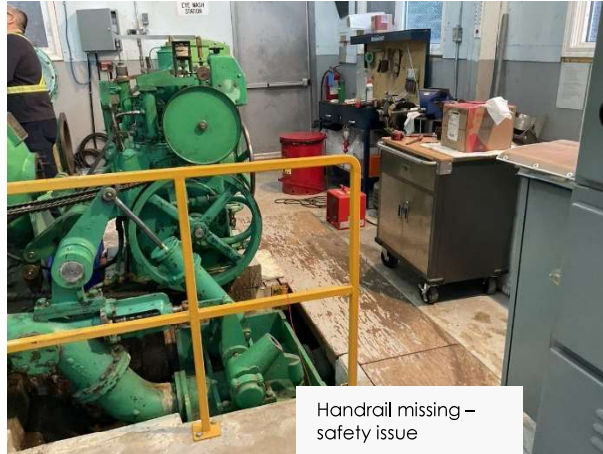
Figure 29: Missing handrails
