2023-2024 General Rate Application (GRA)

Fish Lake 2 Power Station Design

ATCO Electric Yukon
Fish Lake 2 Condition Assessment
Fish Lake, YT

Technical Report
Condition Assessment and Options Analysis

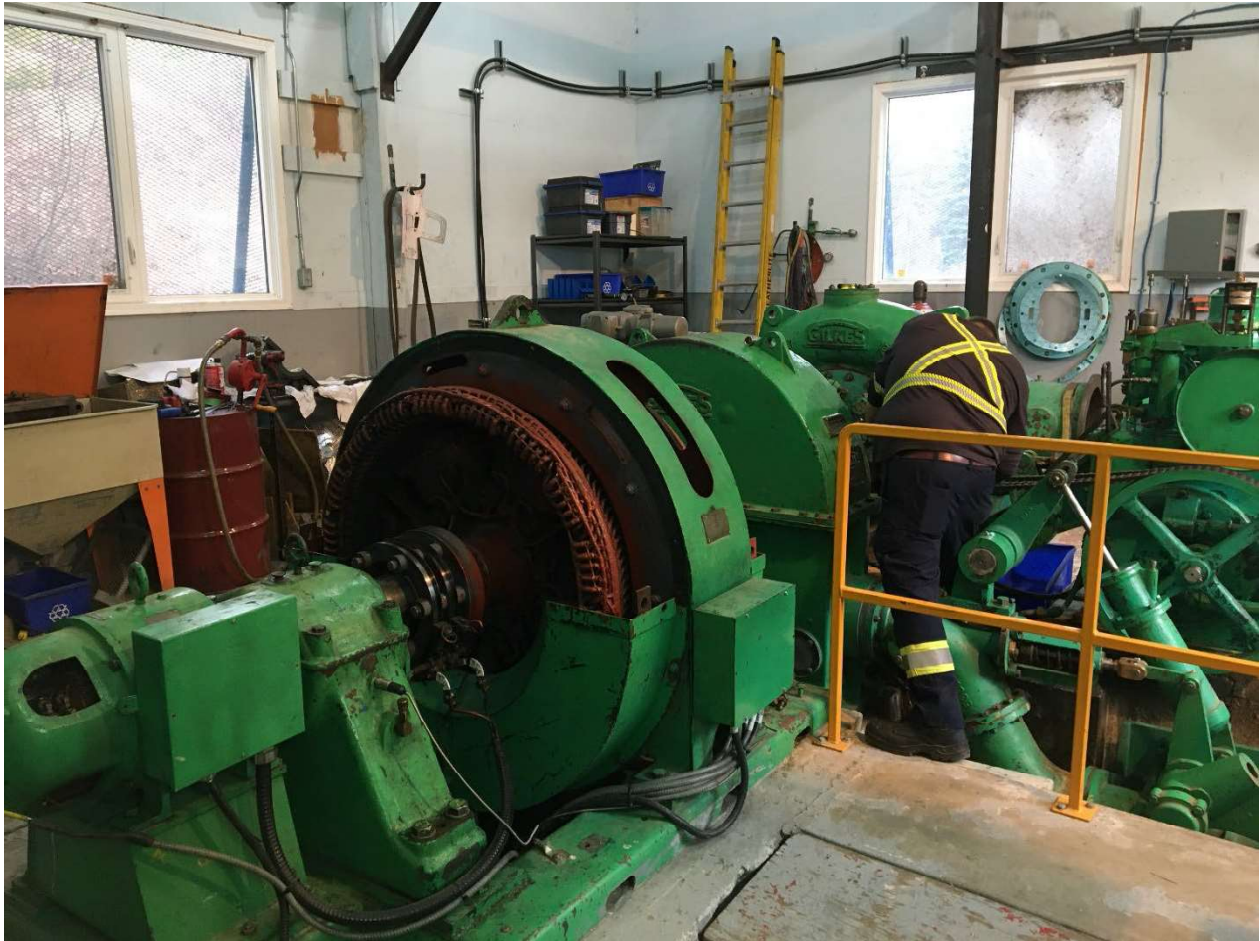
Figure 1: Turbine and Generator

The Fish Lake 2 generator is a horizontal, 812 kVA, 1200 RPM, 2300V, 3 phase Westinghouse generator with an 800 BHP (600kW), 200 ft head Gilkes Francis hydro turbine. The unit was installed in Fish Lake 2 in 1954. It is presently 68 years old and maximum output is reported to be 480kW.

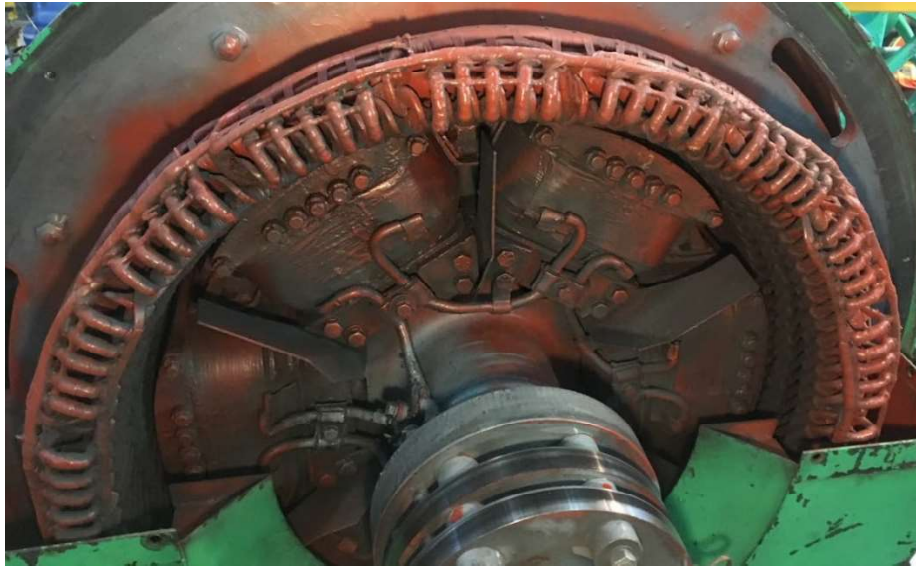
Figure 11: Generator Windings

appear to be lashed tightly and are in good condition with no discoloration, dusting, cracking of the insulation, or flaking of the grading paint.

According to the Maven Report the stator was rewound in 2000 and appears to still be in good condition. Contributing to the condition is no doubt the fact that the generator has been operated approximately 25% below its maximum nameplate rating for most of its life.

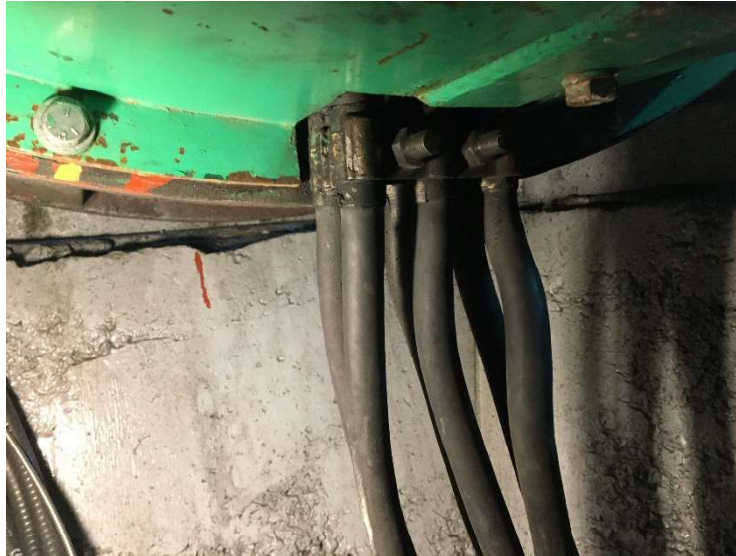
Figure 20: MV Cables Under Generator

The MV cables appear to have been replaced since the original installation, most likely in 1999 when the new switchgear was installed.

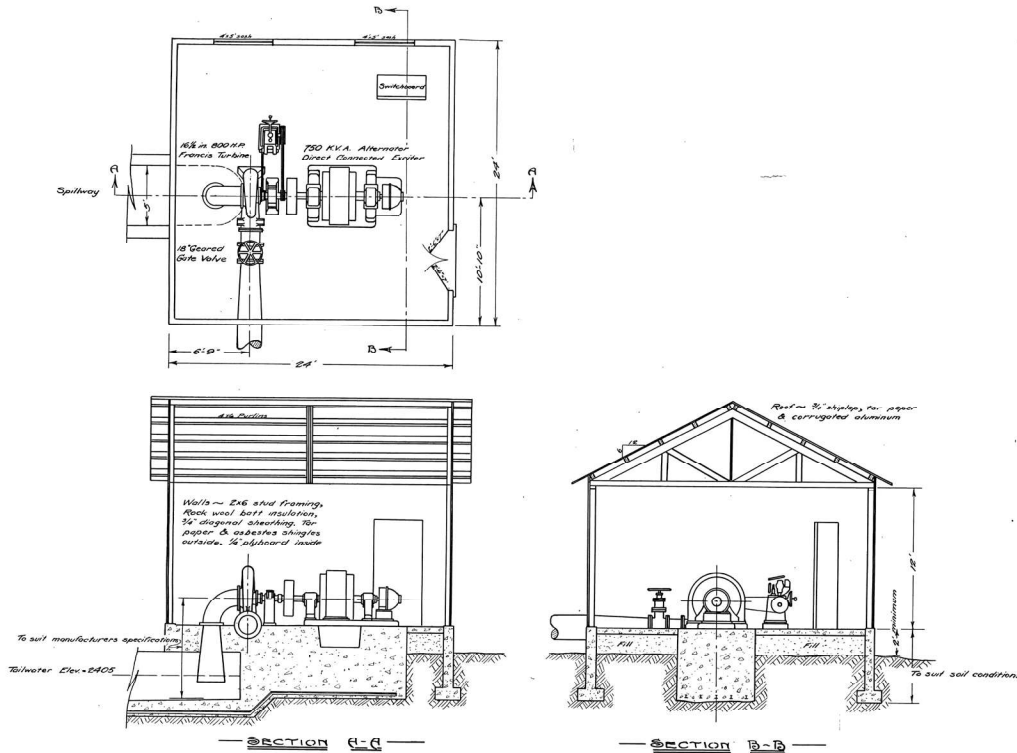
Figure 21: Powerhouse building

The building is a single-storey wooden frame building with wooden roof truss hosting a turbine/generator. The building layout is shown Figure 21 below.
